# QUALITY CONTROL AND NONDESTRUCTIVE TESTING FOR THE PREVENTION OF FAILURES IN SCIENTIFIC SATELLITES

A. J. Babecki

NASA - Goddard

<sup>1.</sup> Paper submitted to the Sixth National SAMPE Symposium, Seattle, Washington, November 18–20, 1963.

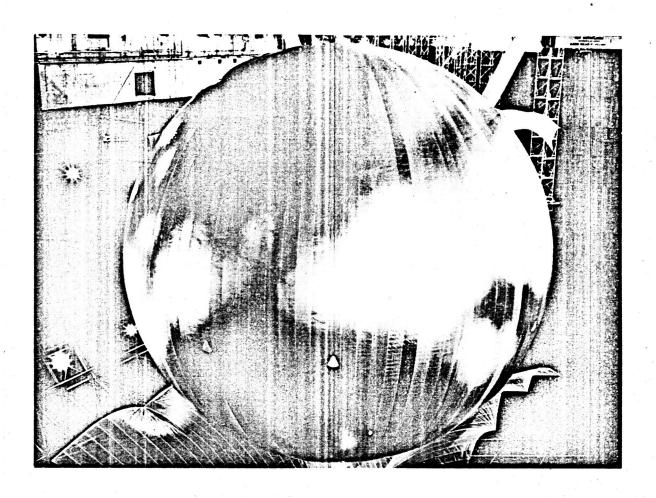
Figure 3. Echo II Full-Size Model During Static Inflation Test.

The following are some examples of areas where problems have developed which could have been prevented by more adequate quality control and non-destructive testing. It is true in some cases that the significance of a condition to good performance was not known until after failure occurred. In the case of the attempt to launch a second Echo satellite, motion pictures taken by a camera recovered from the launch vehicle showed that the balloon ripped open on inflation. In an attempt to determine why, the aluminized mylar and other balloon materials were subsequently examined. Briefly, what the study showed was that the plastic films generally do have orientation stresses residual from the manufacturing process. These residual stresses re-

duce the ability of the plastic to take the rapid inflation stresses without tearing. At low inflation rates, they fair better; so one approach is to regulate the rate of sublimation of the inflating chemical.

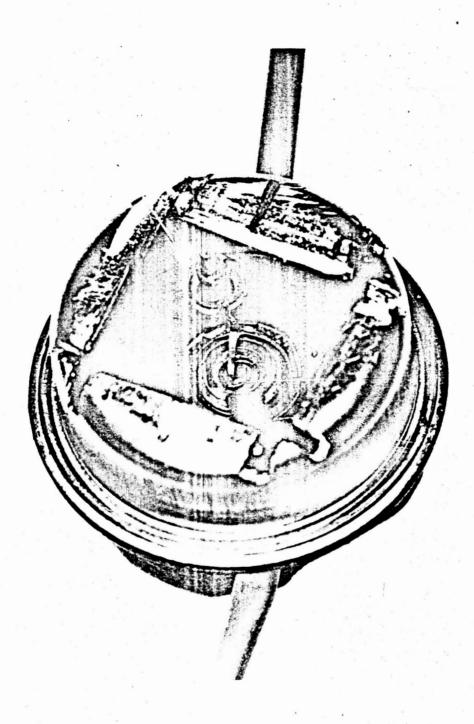
Another hermetically sealed transistor developed malfunction after a storage test at 200°C for 168 hours. After vibration testing it returned to normal operation. Subsequent opening of this unit discipsed a loose flake of solder which was believed to have caused the trouble. The explanation advanced is that the solder flake had caused a high-resistance short between the base and collector. Subsequent vibration testing then loosened the flake from its shorted position and returned the transistor to normal

ir Id**ed**  operation. A similar examination of 16 such transistors after testing revealed that three had loose solder flakes. Better quality control is certainly required in this case.

Figure 17. Interior View of Transistor Seen in Figure 16.
